Introduction

360° Testing Service has been retained to conduct impact testing of the client's athletic cups plus cups from two competitors; see the photo to the right. From left to right:

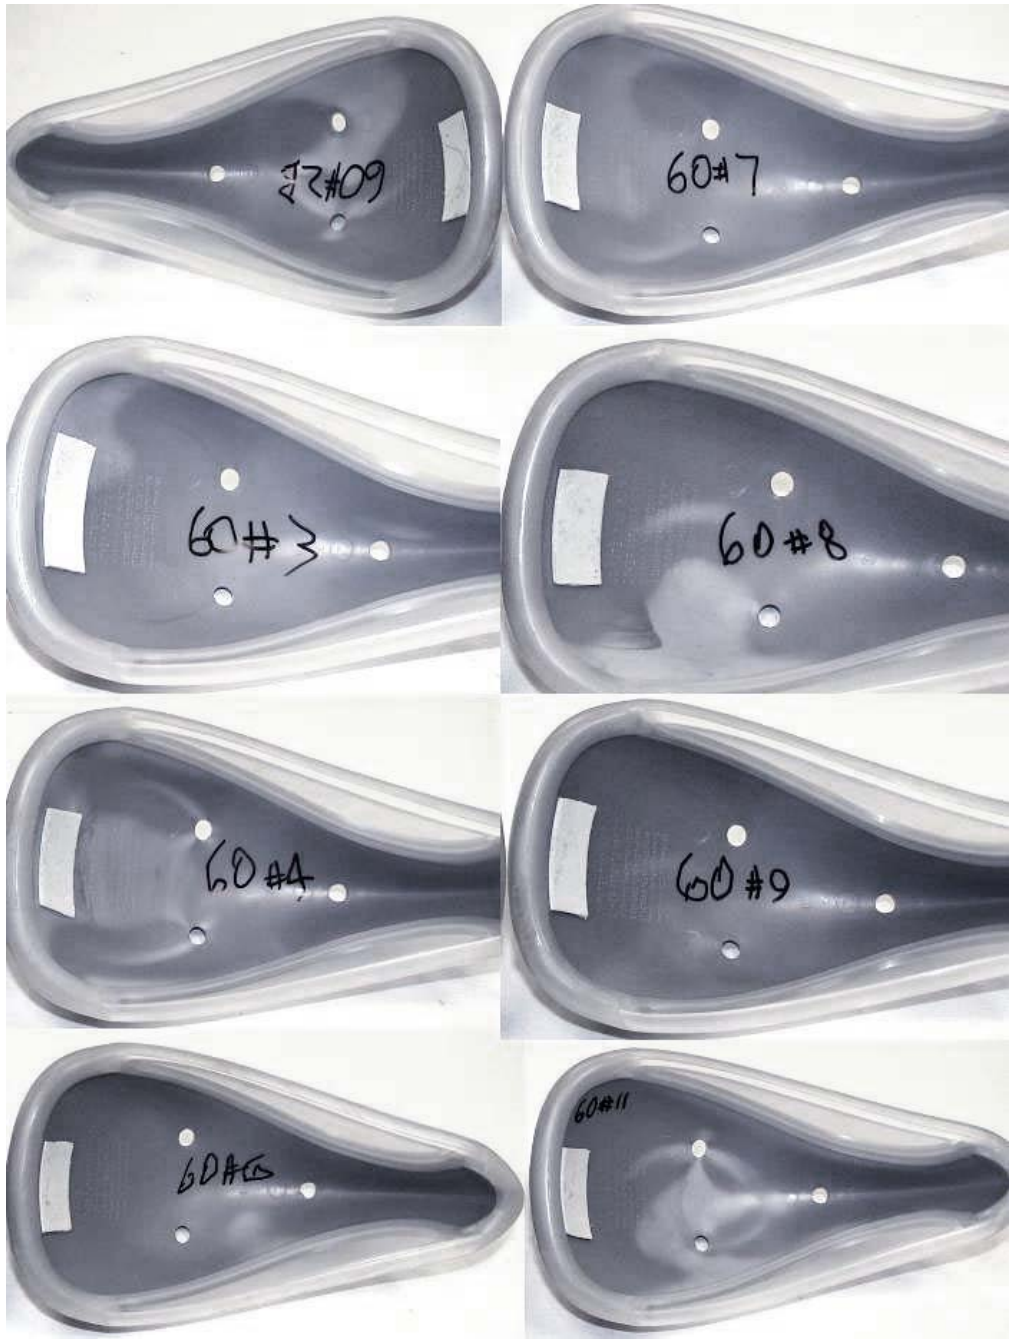
on the inside of the cup where it had deformed. The ball would often leave a visible mark on the exterior surface of the cup, on the opposite side of the stress mark. Stress marks were not generally visible on the outside of the cup except around ventilation holes. One cup appeared to crack but the cracks appear to be inside the plastic; no break in the material can be felt on either the inside or outside. What appears to be a small crack in one cup may not actually be a crack, however, since there is neither any feeling of a break in the plastic, nor a stress mark around the crack. As seen in the photo on the following page, most of the Brand - 3 cups, after being struck at 60 mph, show highly visible stress marks on the interior surface.

Impact stress marks on Brand - 3 cups struck at 60 mph

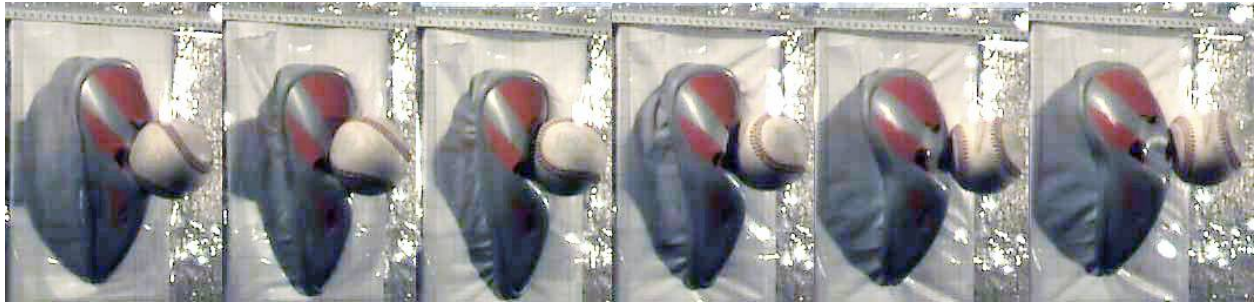
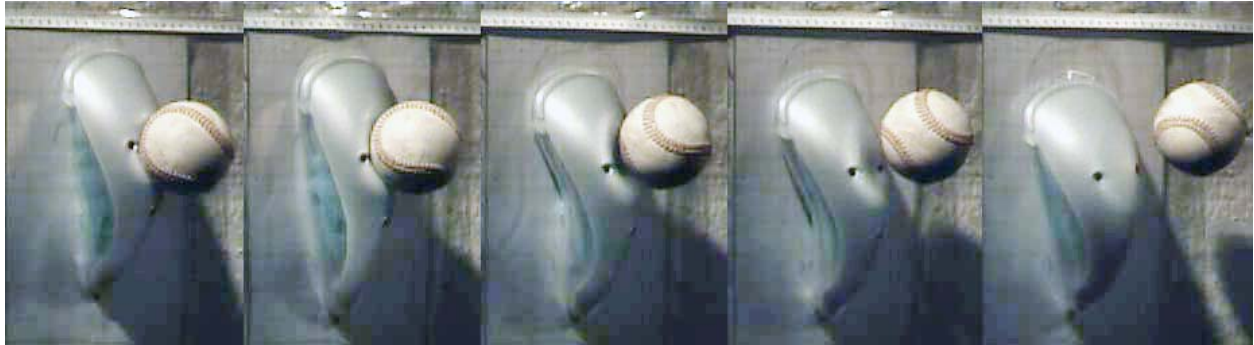
Deformation of a Brand - 1 cup - A (top) and Brand - 3 cup - C (bottom) when struck near the center at 60 mph. This particular impact cracked this cup - A, as seen in following photos. The cup - C exhibited stress marks on the inside; this particular cup was labeled "60 #11" and the resulting stress marks can be seen in the photo at the bottom of page 3.

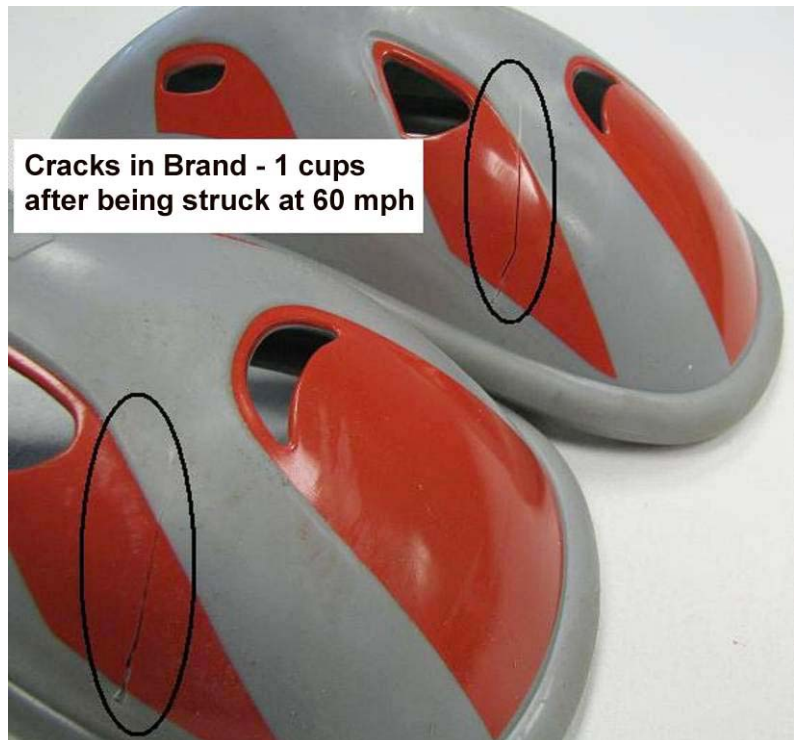
- Two Brand - 1 cup - A cups cracked when struck at 60 mph; the photo series above shows one of those two cups. The ball struck each cup at almost the same location, just to the right and slightly above the center. The photo at right shows the almost-identical cracks in the two Brand - 1 cups.

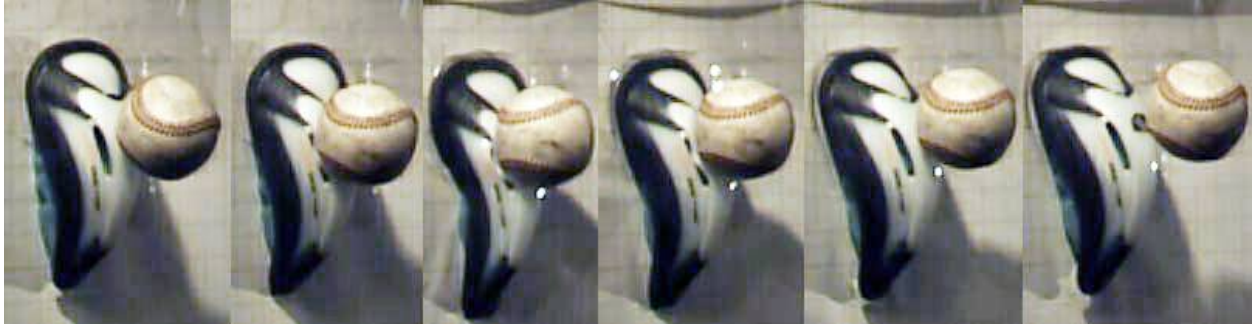
- When struck at only 30 mph, the Brand - 2 cup - B noticeably deformed, as seen in the following photo sequence.

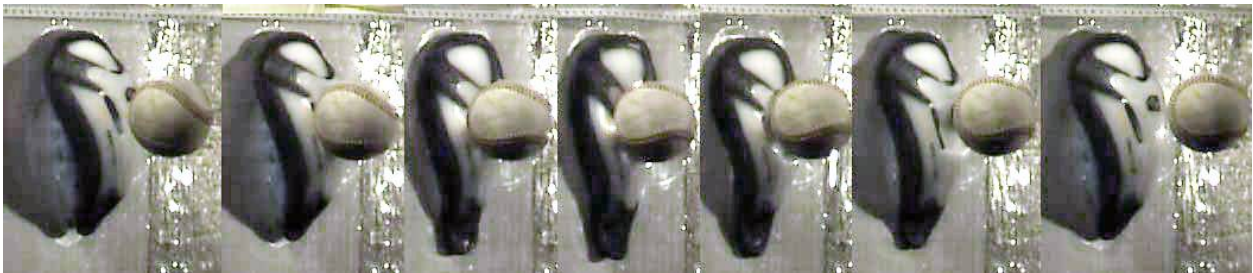
A Brand - 2 cup being struck in the center at 60 MPH. Note, in the 4th photo of the sequence, how the cup appears to flatten completely.

However, no damage of any kind was found on a struck Brand - 2 cup other than some “plastic burn” resulting from the ball spinning on the surface of the cup.

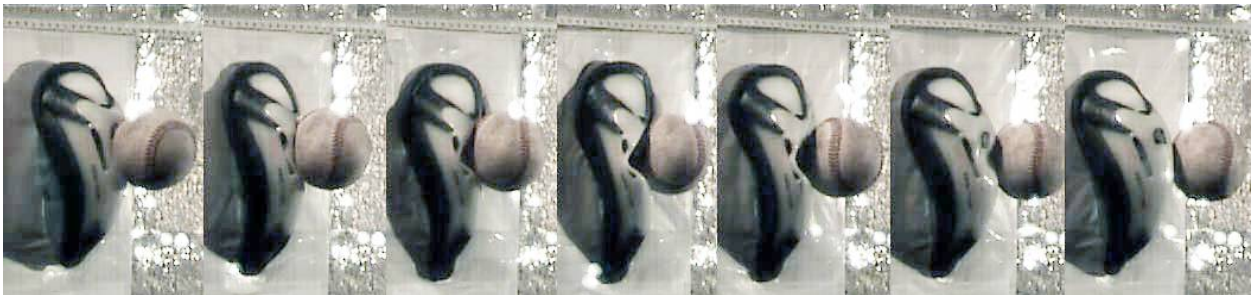
- Another 60 mph strike on a Brand - 2 cup, slightly off center, caused the cup to deform inward where it was struck, as seen in the following photo sequence. The ball is clearly following the shape of the cup and rolling off to the side, where it might have struck the cup-wearer’s body.

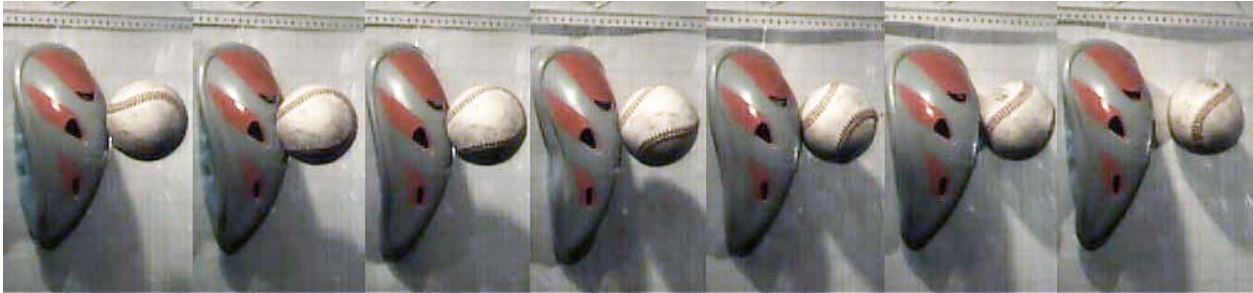
- When struck at 30 mph, a Brand - 1 cup - A barely deformed inward, as seen in the 2nd and 3rd photos of the following sequence. The ball struck this cup slightly off-center toward the far side, compressing that portion of the cup, then rolled down the side of the cup until it struck the backstop behind the cup. Part of this rolling is clearly

due to the very fast spinning of the ball but part is also due to striking the cup slightly off-center.

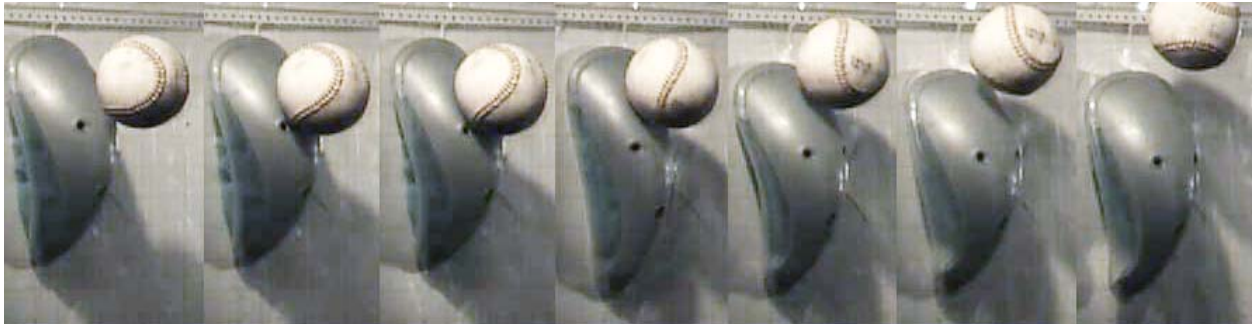
- The following photo sequence shows a cup - C being struck at 30 mph slightly above the center of the cup, on the upper flat surface (2nd, 3rd and 4th photos in the sequence). Note how the cup deforms slightly, and then appears to shove the ball off. The ball does continue rolling “up” the flat surface but is repelled from the cup before contacting the cup wearer’s body.

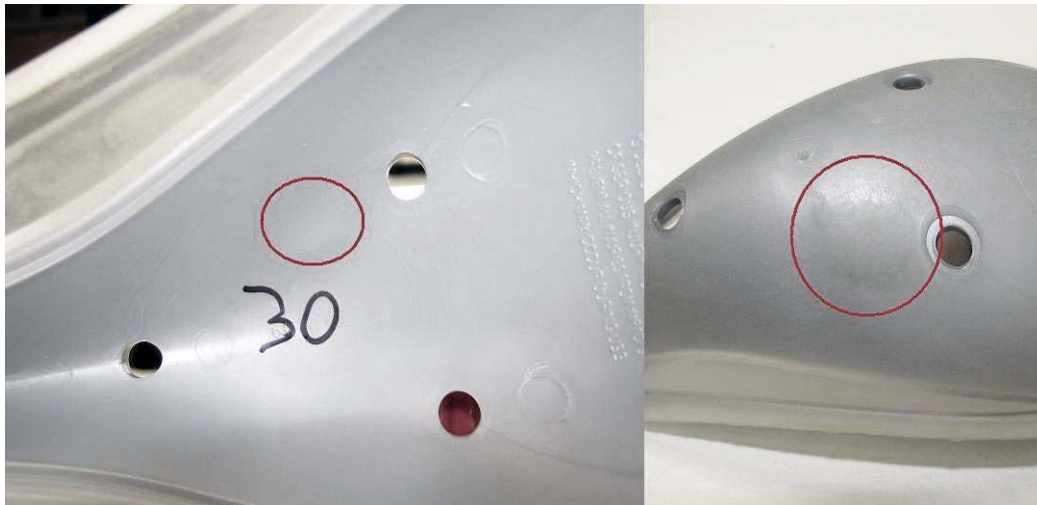
This particular strike left a barely-discernable stress mark on the inside of the cup. The ball left a much-more-visible “wear mark” on the outside (pictured below).

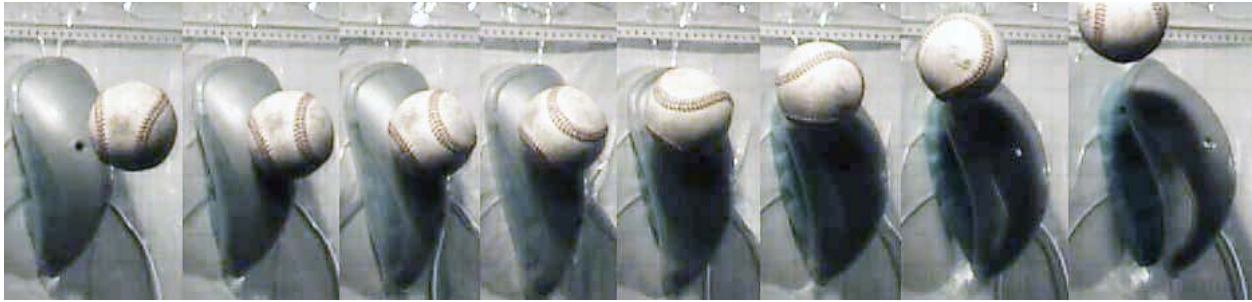
- A second 30 mph strike on a Brand - 3 cup - C, this time slightly to the left of center, appears to have caused slightly more inward compression of the cup, as seen below in the 3rd photo of the sequence. Note that again, the ball is thrown back off the cup before it has had a chance to roll down onto the cup wearer’s body.

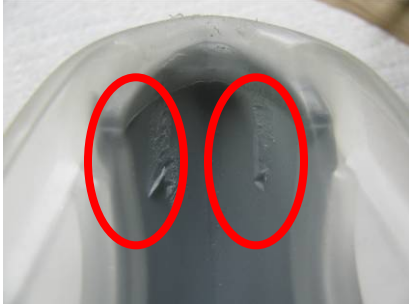
<p>Typical 40mph damage:</p> <p>The most common damage found was from the impact with the sharp edges of the load cells, and not due to performance of the protective device. In most cases there was no structural damage noted; except as described below.</p>

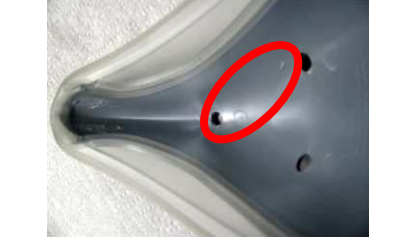
<p>60mph damage:</p> <p>The plastic regions near and between the ventilation holes show signs of plastic strain. These areas are the higher stress points that will likely be the first points of any failure or cracking.</p>

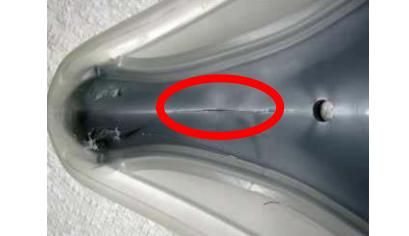
<p>60mph damage:</p> <p>The second gray sample, after three (3) impacts at 60 mph, suffered a crack along the centerline from the lowest hole toward the narrow tip.</p>

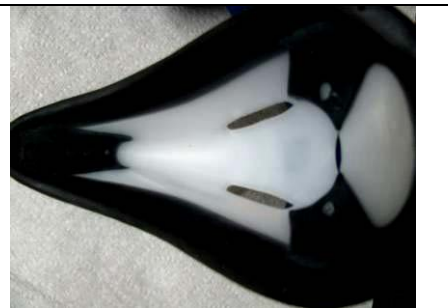
After three (3) impacts at the equivalent 60 mph setting, the Brand - 2 cupl did not show any signs of fatigue, stress, or cracking.

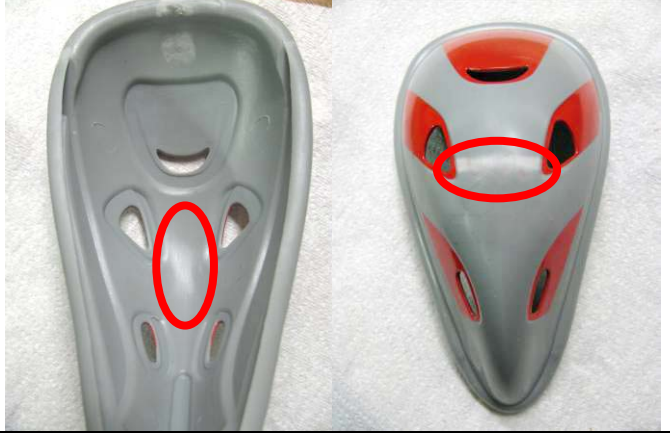
<p>60mph damage:</p> <p>After one hit on the first sample, very visible stress fatigue marks appeared between the ventilation holes. The plastic stress marks are visible on both the inside and outside of the cup. The 60 mph baseball impact created the same fatigue pattern.</p>

The red and gray Brand - 1 cup - A consistently displays stress flexure marks between ventilation holes when impacted by a 60 mph ball (or equivalent). This is due to the local plastic area exceeding the plastic strength. This can be improved with slightly additional thickness or plastic additive. This device generally absorbs the most energy of the products tested.

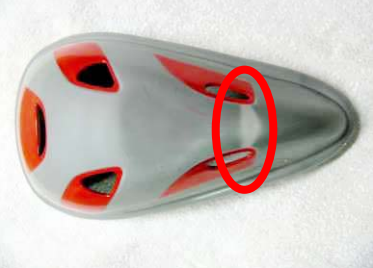
<p>60mph damage:</p> <p>The single impact on the second sample landed slightly lower. The same behavior of the plastic stress mark immediately appeared between the lower ventilation holes.</p>

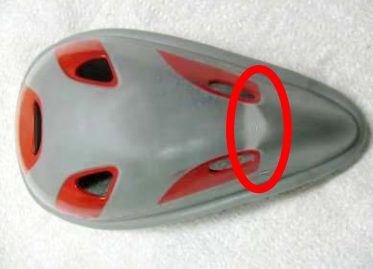
<p>60mph damage:</p> <p>The single impact on the third sample landed slightly lower than the impact on the second sample; but the stress marks that appeared look almost identical to those on the second sample.</p>
