Introduction

360° Testing Service has been retained to conduct impact testing of the client's athletic cups plus cups from two competitors; see the photo to the right. From left to right:

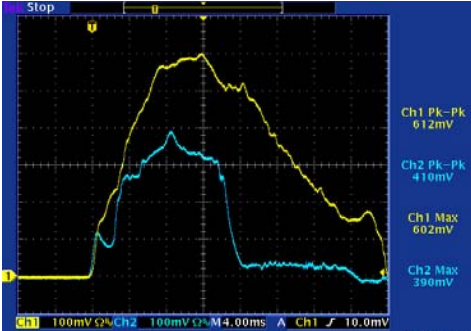
<p>Ch1 Pk-Pk 612mV Ch2 Pk-Pk 410mV Ch1 Max 602mV Ch2 Max 390mV 1 Nov 2009 17:20:21</p>	No damage
2	Brand - 3 #1	40 mph	76.2	86.2

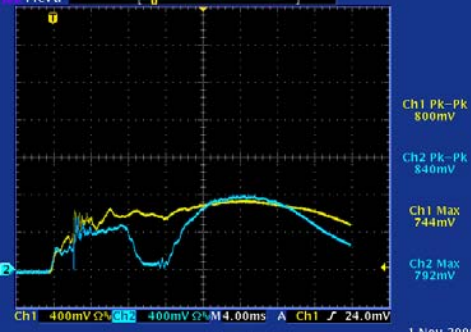
<p>Ch1 Pk-Pk 800mV Ch2 Pk-Pk 340mV Ch1 Max 744mV Ch2 Max 792mV 1 Nov 2009 18:16:48</p>	No structural damage; slight abrasion w/load cell
3	Brand - 3 #1	40 mph	253.3	227.7

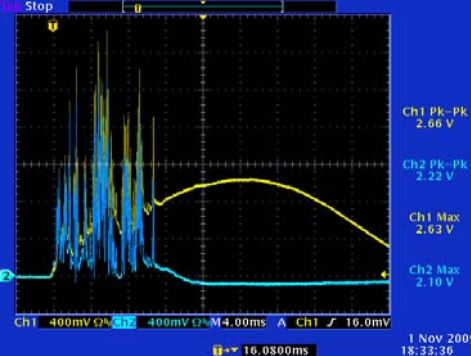
<p>Ch1 Pk-Pk 2.66 V Ch2 Pk-Pk 2.22 V Ch1 Max 2.63 V Ch2 Max 2.10 V 1 Nov 2009 18:33:36</p>	Oscillating impact frequency. Test setup vibration.
