Introduction

360° Testing Service has been retained to perform functional, durability testing and analysis upon provided Brand mixers, as shown to the right. This testing included:

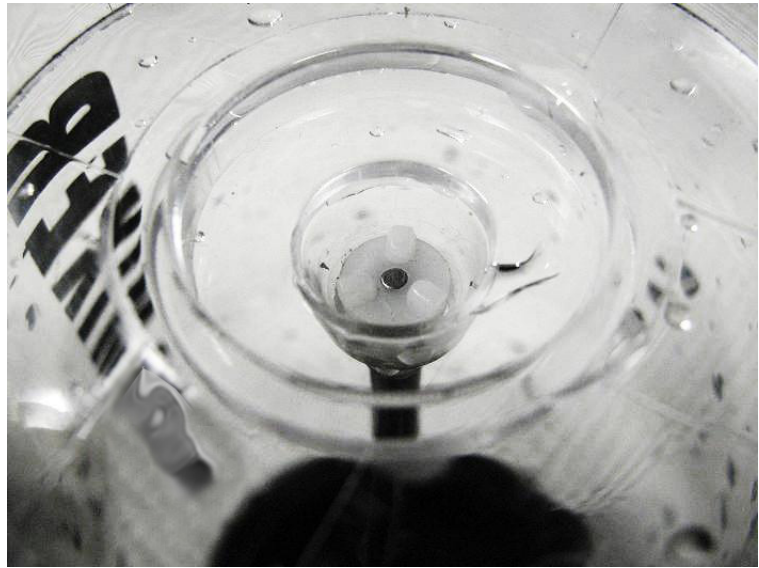
When first tested, the mixer stirrer of CM02 would not rotate at all, and the stirrer of CM03 rotated very erratically. Later, after the concoction-mixing tests, close examination revealed that the pinion gear might be pressed too far onto the stirrer shafts, causing the stirrers to bind; see the photo at right.

In response, engineers pressed out the steel shaft by about 0.010” on CM02, which then allowed the stirrer to be easily spun by hand (by reaching into the cup) with less friction. After this “adjustment”, the motor to able spin the stirrer. In fact, the difference is such that CM02 achieved the highest motor RPM of the three when stirring 8 fl. oz. of water, 16,667 RPM. In contrast, CM01 spun only 40% of that speed while CM03 spun about half the speed of CM02. This spacing of the pinion gear on the stirrer shaft seems to vary somewhat between the three MM units due to slight differences in the silicone gland seal mounted under the stirrer, inside the cup. This seal prevents liquids from leaking down the shaft.

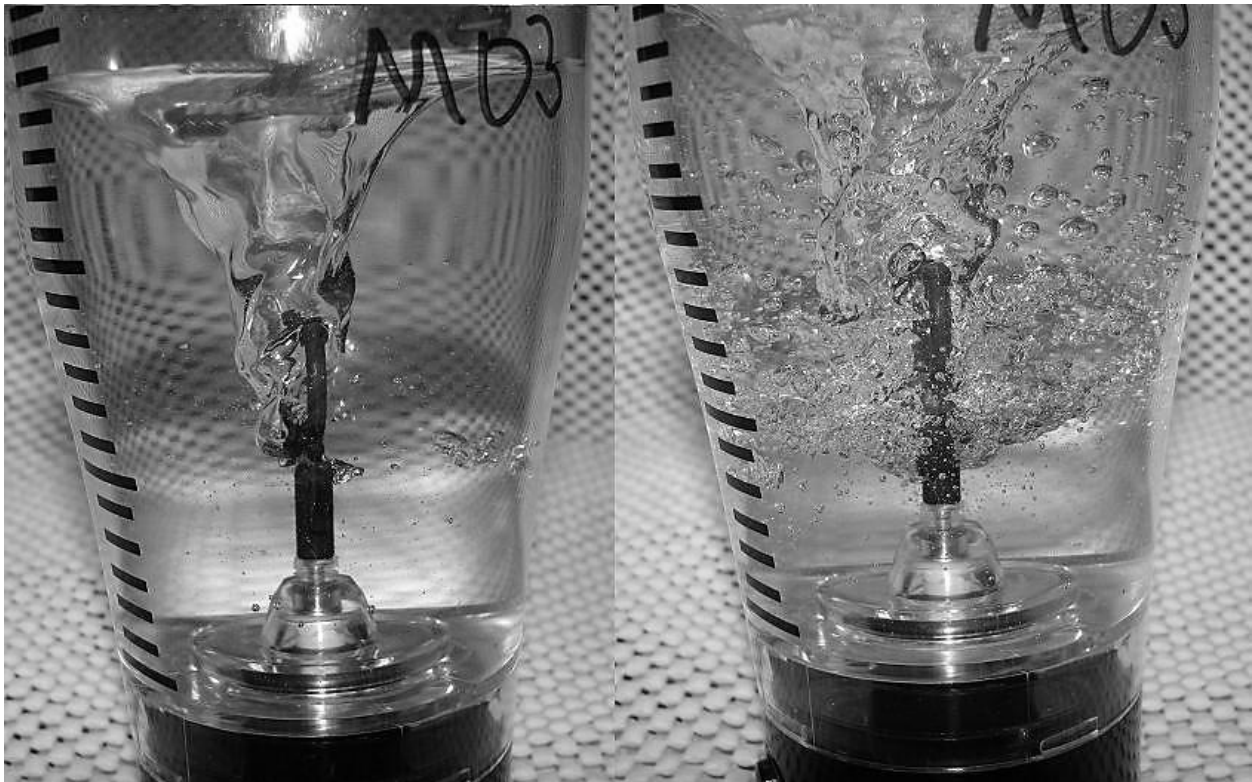
It should be noted that when the mixer is first turned on and the stirrer is spinning at slow speed, there is no vortex with air mixing taking place and this increases the load on the motor; thus, at minute 0, the current can be seen to be highest. After the stirrer has attained sufficient speed as to cause vortex with air, the current then drops since the motor is doing less work. The following two pictures of CM03 illustrate the difference between vortex only and vortex with air mixing.

As the stirrer begins rotating, the rotating motion of the stirrer causes the liquid to rotate within the cup, which gradually causes a vortex to begin forming downward from the surface of the liquid. As the vortex stretches down to and reaches the stirrer, the stirrer mixes air drawn from the vortex into the liquid, then the lower arms of the stirrer toss the air around in the liquid. As air is tossed outward from the stirrer's lower arms, air-mixing occurs which causes the stirrer to encounter less liquid and more air, thus causing less mechanical resistance. The reduction in spinning-resistance lessens the torque requirement on the motor, allowing it to spin faster. The turbulence of the air being mixed in the liquid causes a constantly changing torque on the stirrer which causes the motor speed to jump up and down as the arms of the stirrer alternately encounter air and liquid.

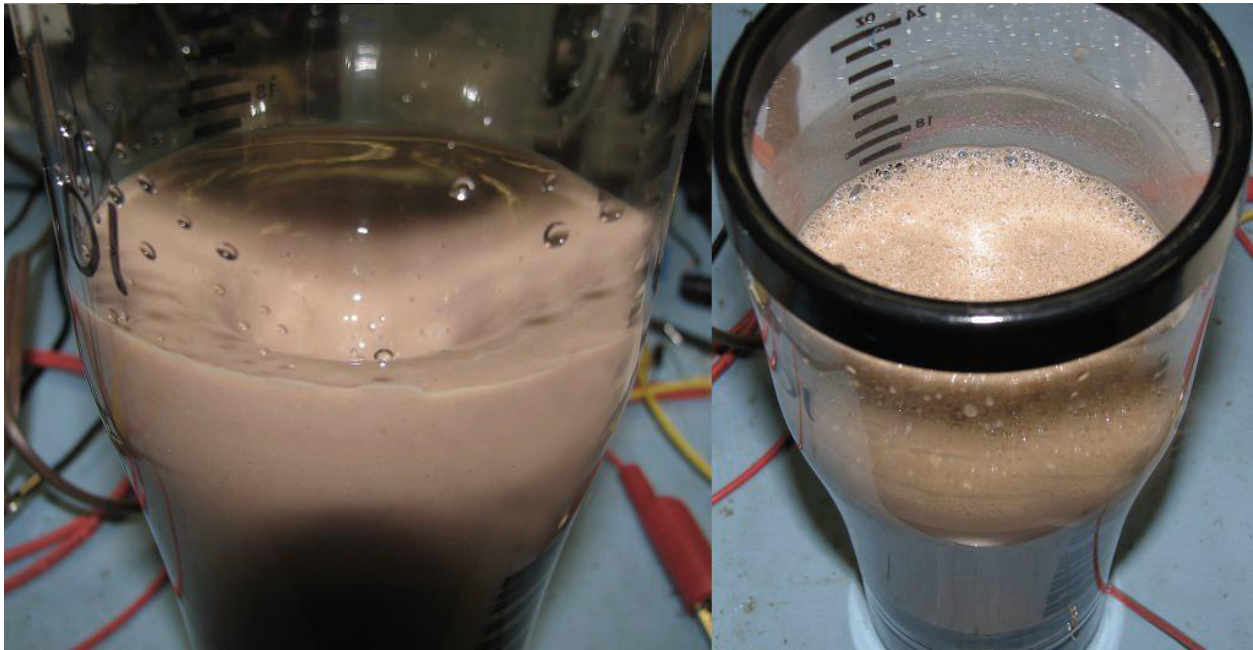
Thus, while mixing the concoction, motor current remained much higher than was the case while stirring a thinner liquid such as water. When mixing 8 fluid ounces of concoction using CM01, 360° observed the motor current at 1.9 amperes while the power supply held the voltage to the motor constant at 3.14 volts. The rotational speed appeared to be about 1500 RPM, considerably slower than when mixing the same volume of water. While a vortex did form, the vortex apparently never brought enough air down to the stirrer to allow vortex with air to begin (had vortex with air begun, the motor would have drawn less current, thus extending battery life). The left-hand photo below shows a clear vortex formed while the concoction was being mixed; the right-hand photo illustrates the thoroughness of the mixing process after two minutes.

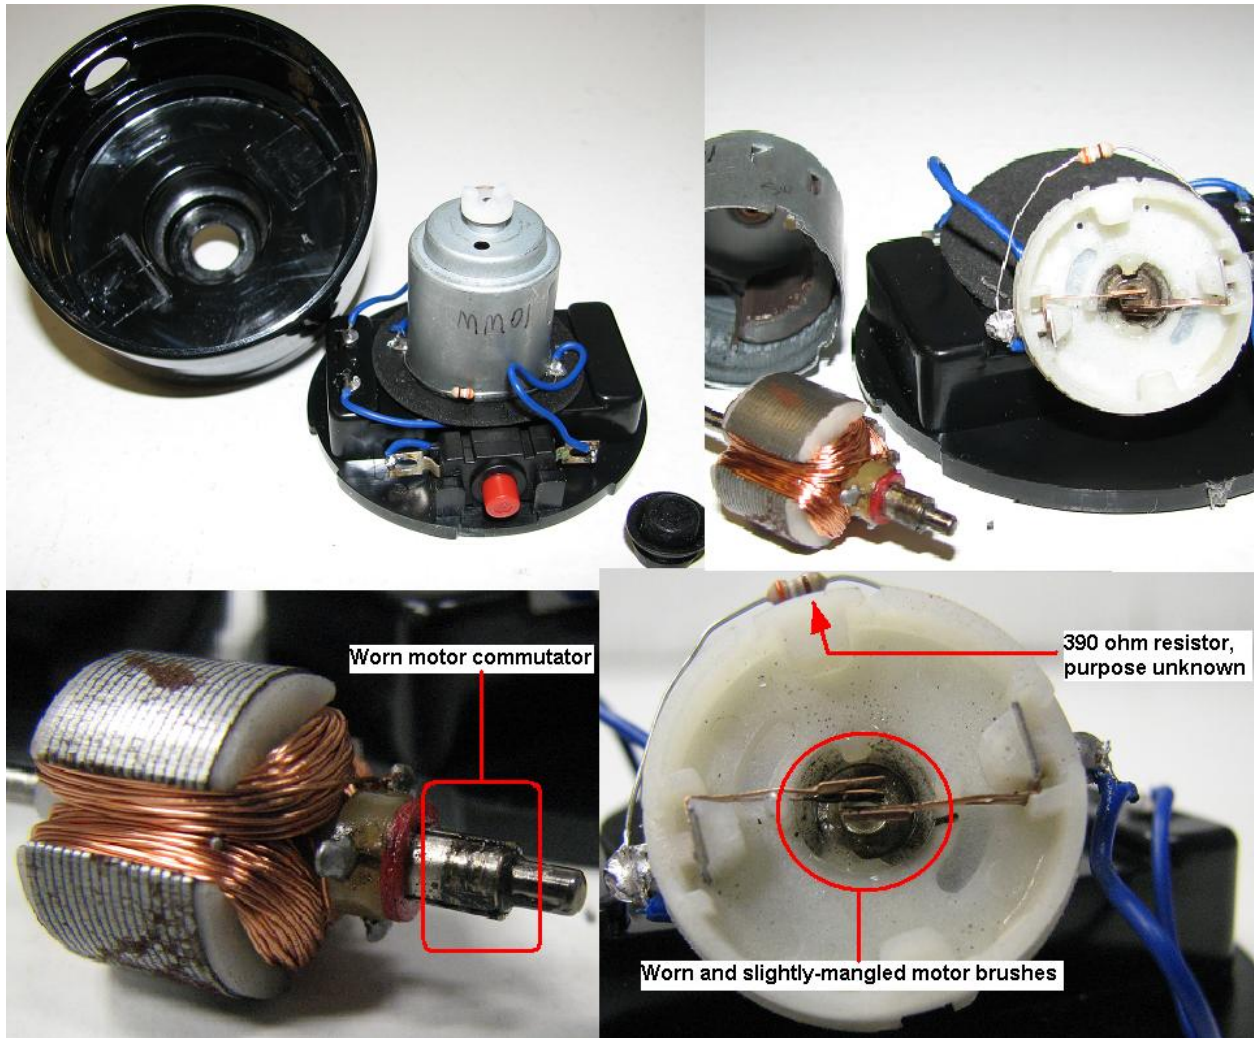
The DC motor used in the Brand mixers is a standard 2-pole, 3-coil type, as shown in the photos on the following page. The pictured motor is from CM01 and has been operated off-and-on, with liquid and without, for about 45 minutes. It is already showing signs of wear on the commutator and brushes; note the uneven edges on the sides of the three commutator pieces, and the bent motor brushes. Although a slight amount of bending of the brushes occurred when the motor was disassembled, there is also some bending of one brush that could not have occurred during assembly or disassembly. The end of the motor shaft that rides inside a bronze bushing also shows signs of wear.

A 390-ohm resistor can be seen mounted across the motor terminals on the exterior; the purpose of this resistor is unknown, but will cause a small amount of current (approximately 7 milliamperes at 3.0 volts) to be drawn while power is being applied to the motor. A resistor across the motor terminals will not affect any commutator-brush sparking, whereas a small capacitor might reduce such sparking.

No manufacturer or part number markings were found on the motor (the CM01 seen was written on the motor case for ID purposes).

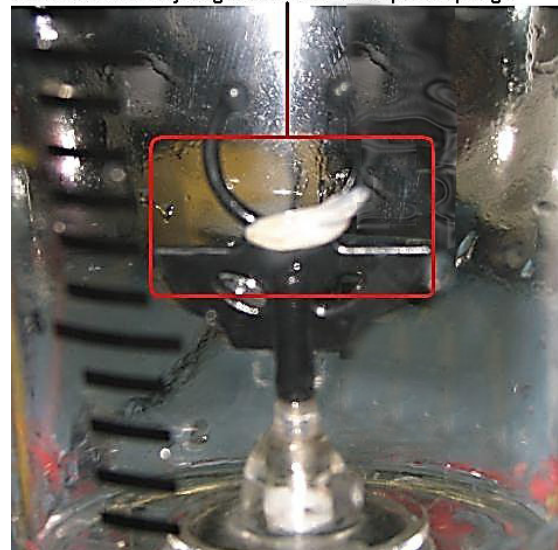
The mixer cup is a thick polystyrene casting. Unlike a standard household blender, however, the bottom portion holding the stirrer cannot be removed for cleaning. The narrow cup's depth makes it difficult for a large hand to reach inside with a sponge or other appliance to wipe off the stirrer or bottom of the cup. When eggs are mixed with the Brand mixers, portions of the liquid embryo tend to get wrapped around the stirrer, as seen in the photo at right.

Egg embryo wrapped around mixer stirrer that did not wash away with water. To clean this off, it was necessary to gently dab at the relatively-fragile stirrer with the tip of a sponge.

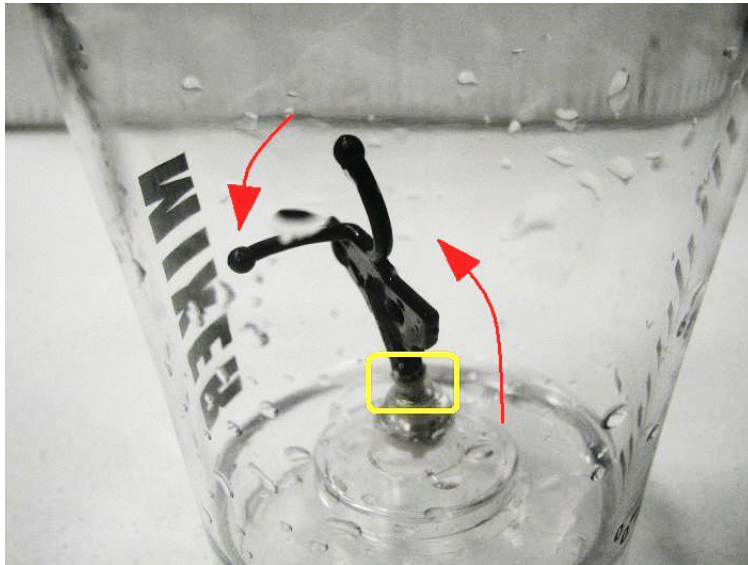
Underneath the black mixer stirrer is a silicone gland that provides the liquid-tight seal around the mixer shaft. However, **after about 30 to 40 minutes of intermittent use, the silicone gland on CM01 began leaking water**, which ran down the stirrer and then the motor shaft. Close examination of the other two mixers also found several drops of water in the motor compartment of CM03; CM03 had approximately 20 minutes of intermittent (usually about 2 minutes each) usage.

The yellow rectangle highlights where the silicone liquid-tight gland is located.

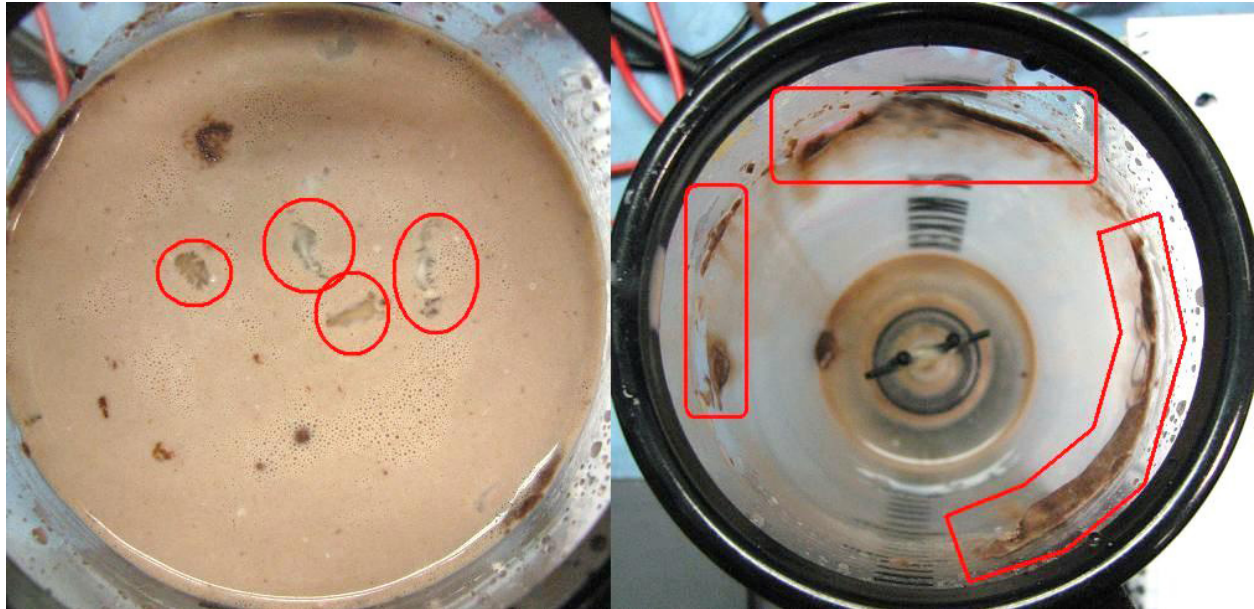
Engineers found that for best mixing performance, only 8 fluid ounces liquid should be mixed at a time within the MM cups. During 360°'s first concoction mix, engineers attempted mixing 12 fluid ounces of milk, but the rest of the concoction ingredients were as previously described. This turned out to be too much liquid, and the stirrer was unable to draw a deep vortex that caused the materials to be stirred properly. As a result, after 2 minutes of mixing, there were still pieces of egg visible on the top of the concoction, as seen in the red highlighted areas in the photo to the left below.

In addition, if a powdered mix is to be mixed with liquid, the mix should be dropped into the cup and the cup slightly stirred/agitated to let the mix sink below the surface of the liquid. If the powder is allowed to sit on top of the liquid when the mixer is turned on, the powder can become deposited on the walls of the cup, as seen in the above right-hand photo within the highlighted areas. Mixing only 8 fluid ounces at a time, and making certain the powder mix has sunken below the surface of the liquid, results in the nicely-mixed concoction seen earlier.
