360° Testing Service performed comparative strength testing of two types of two Client Disher models, as shown to the right.

The two type variations differed in that one type of each model uses a plastic gear while the other type uses a metal gear. There are also slight differences in how the disher scoop is mounted to the plastic handle.

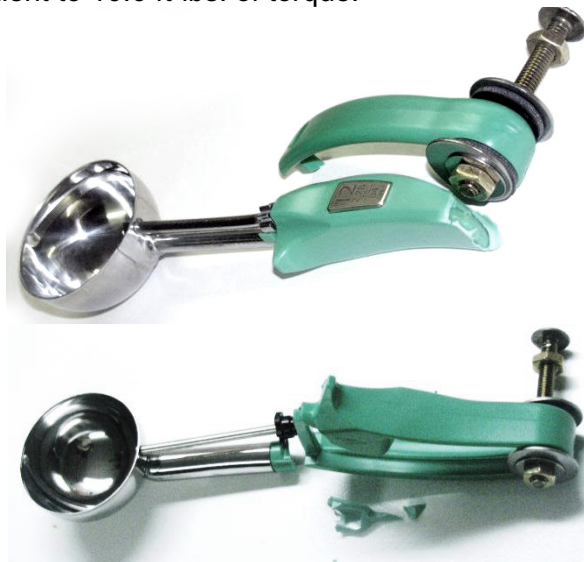
- **Torque:** A perpendicular bolt was attached to each disher at the end of the handle, and then torque was applied to the bolt to twist the plastic handle from the metallic scoop. Knowing the measured lever arm distances and the applied force, the torque was calculated.

The Type-1 (metal gear) broke at the tip of the handle at 115 lbs. applied on a 2 inch moment arm at 112° of rotation. The handle failed at  $(115 * 2)$  230 in-lbs., equivalent to 19.2 ft-lbs of torque. The Type-2 (plastic gear) broke at the interface to the metal shaft at 60 lbs applied on a 2 inch moment arm at 90° of rotation. The handle failed at  $(60 * 2)$  120 in-lbs, equivalent to 10.0 ft-lbs. of torque.

**Type-1** (metal gear): 19.2 ft-lbs. of torque

**Type-2** (plastic gear): 10.0 ft-lbs. of torque

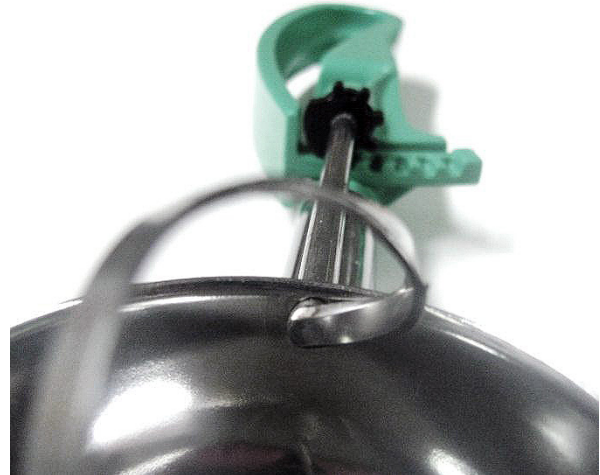
A pull test was performed on the scrapper blade to measure the torque to the weld joint upon failure. Type-1 (metal gear) failed at 10 lbs applied on a 1.25 inch moment arm which is a torque of 12.5 in-lbs (1.04 ft-lbs). Type-2 (plastic gear) continued to spin the gear and shaft. After retesting, the Type-2 disher bent the scrapper blade at 40 lbs on the 1.25 inch moment arm, a torque of 50 in-lbs (4.2 ft-lbs). The photo to the right shows the failed Type-2 scoop blade.

**Type-1** (metal gear): 1.04 ft-lbs. of torque

**Type-2** (plastic gear): 4.20 ft-lbs. of torque

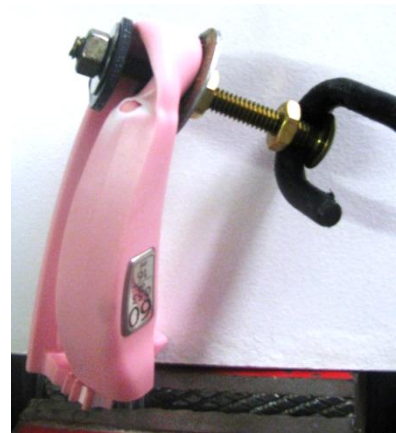
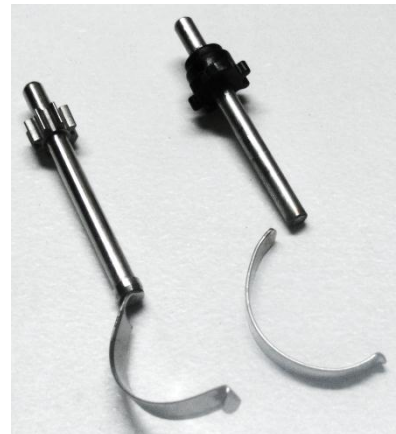
- **Torque:** A perpendicular bolt was attached to each disher at the end of the handle, then tension applied to the bolt to twist the plastic handle from the metallic scoop. Knowing the measured lever arm distances and the applied forces, the torque was calculated.

The Type-1 (metal gear) twisted about 140° at 115 lbs. applied on a 2 inch moment arm. The plastic handle bent significantly at (115 \* 2) 230 in-lbs., equivalent to 19.2 ft-lbs of torque. The Type-2 (plastic gear) twisted about 90° at 50 lbs applied on a 2 inch moment arm at 90° of rotation. The plastic handle was bending significantly at (50 \* 2) 100 in-lbs, equivalent to 8.3 ft-lbs.

**Type-1** (metal gear): 19.2 ft-lbs. of torque

**Type-2** (plastic gear): 8.3 ft-lbs. of torque

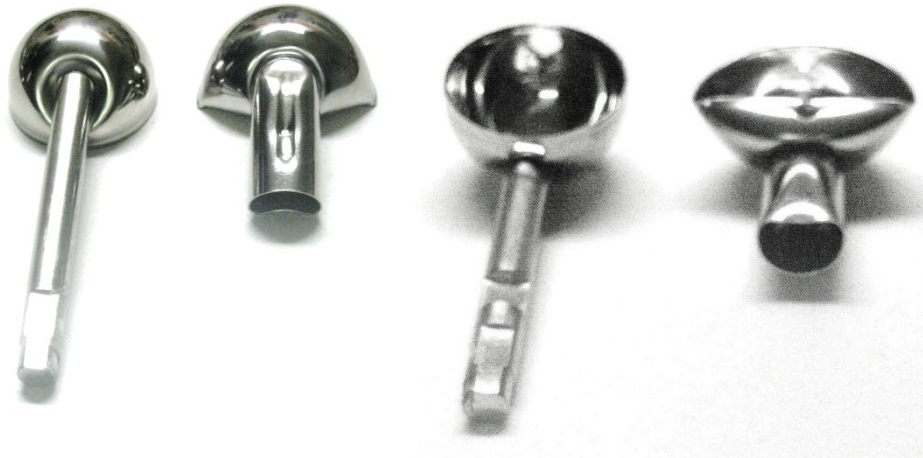
The disher shaft was positioned on a calibrated hydraulic press with an open middle platform. The press was positioned to apply force on the shaft just below the scoop, causing bending between the shaft and the bowl.

The scoops of both of the small dishers deformed without shearing off the shaft. The Type-1 (metal gear) disher had slight bowl deformation at approximately 2000 lbs. The Type-2 disher (plastic gear) exhibited significant deformation at a lower 1100 lbs but the scoop did not break off the shaft. The following photos show the dishers in place on the press before testing, and results after application of the compressive force.
